**INTERIM CORRECTIVE MEASURES IMPLEMENTATION REPORT
ASBESTOS SURFACE IMPOUNDMENT
SOLID WASTE MANAGEMENT UNIT
OCCIDENTAL CHEMICAL CORPORATION
WICHITA, KANSAS**

WESTON SOLUTIONS, INC.

25 July 2008

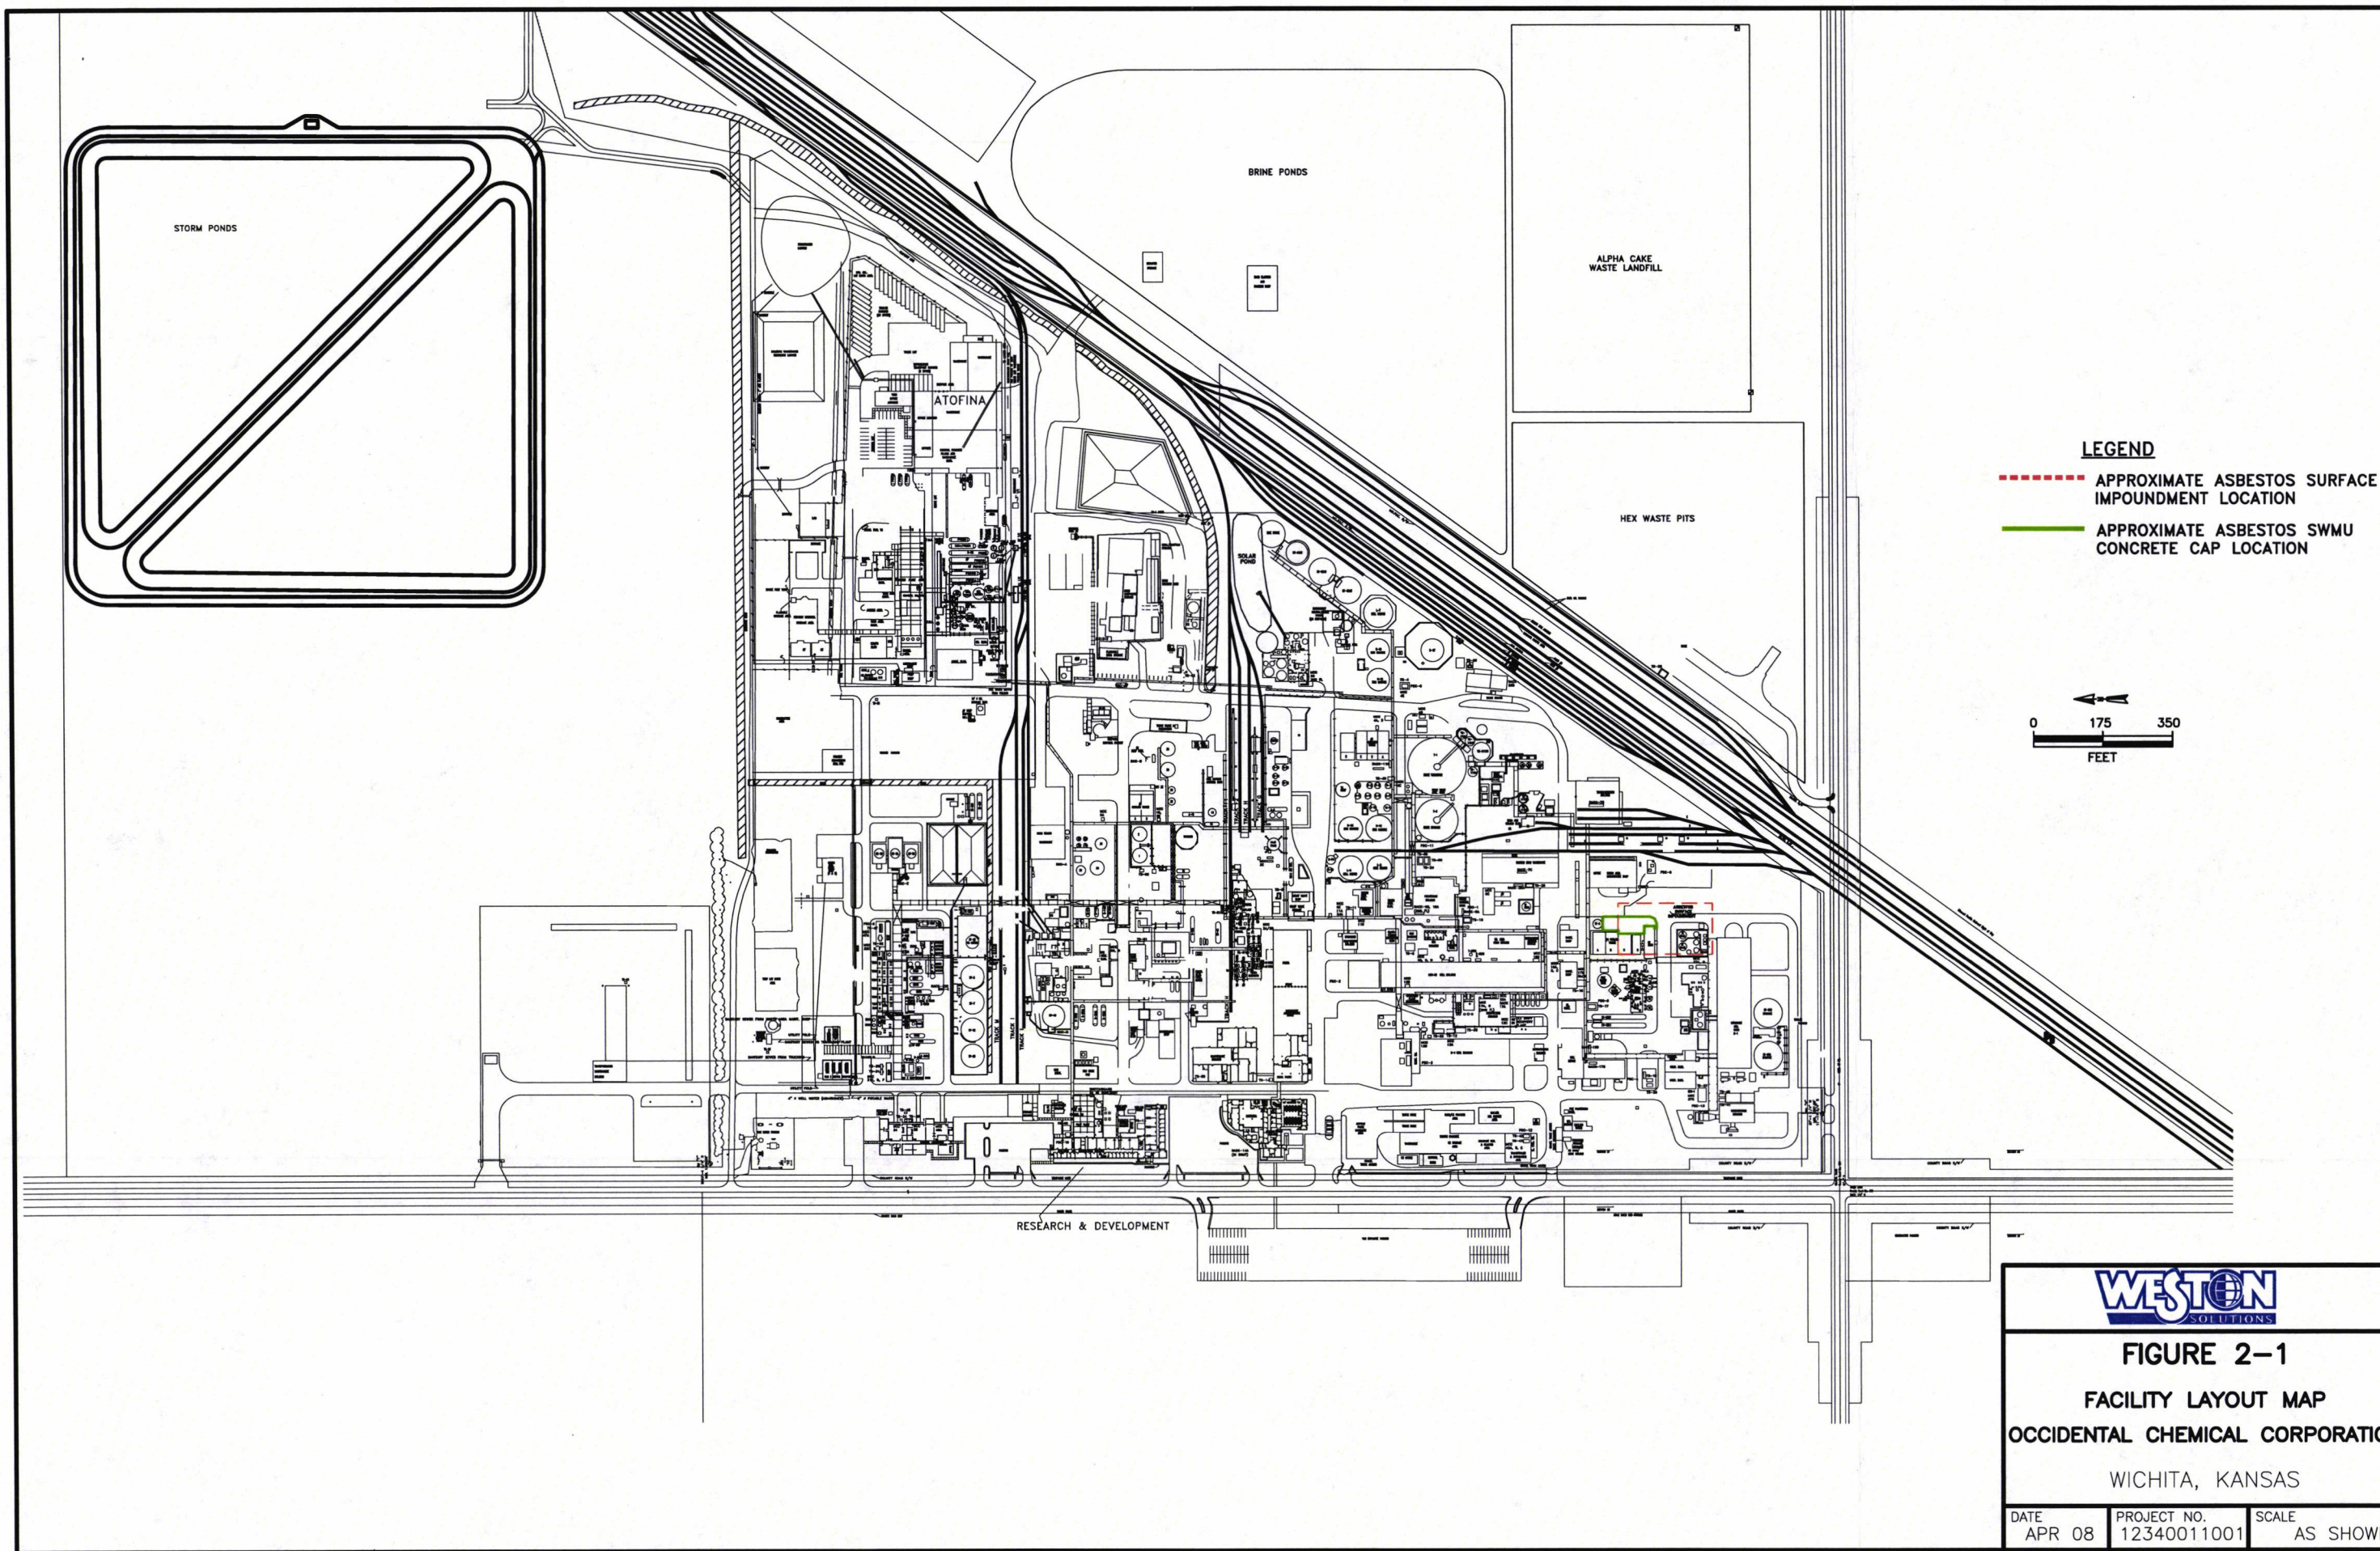
FIGURE 2-1
FACILITY LAYOUT MAP
OCCIDENTAL CHEMICAL CORPORATION
WICHITA, KANSAS

The OCC Wichita facility began operations in the early 1950s as an Inorganic Plant. The ASI operated from 1951 to 1977 in the southern portion of the inorganic production area. Figure 2-1 shows the approximate location of the ASI within the facility. Figure 2-2 shows the estimated size and approximate location of the impoundment relative to existing site features. The impoundment is located directly to the south of Cooling Tower #4, the cooling tower associated with the Membrane 1 Plant, Cell Renewal, and the Chlorine Sniff Plant in the inorganic production area of the facility. Figure 2-3 is a 1961 photograph of the area provided to OCC by U.S. Environmental Protection Agency (EPA) Region 7 personnel.

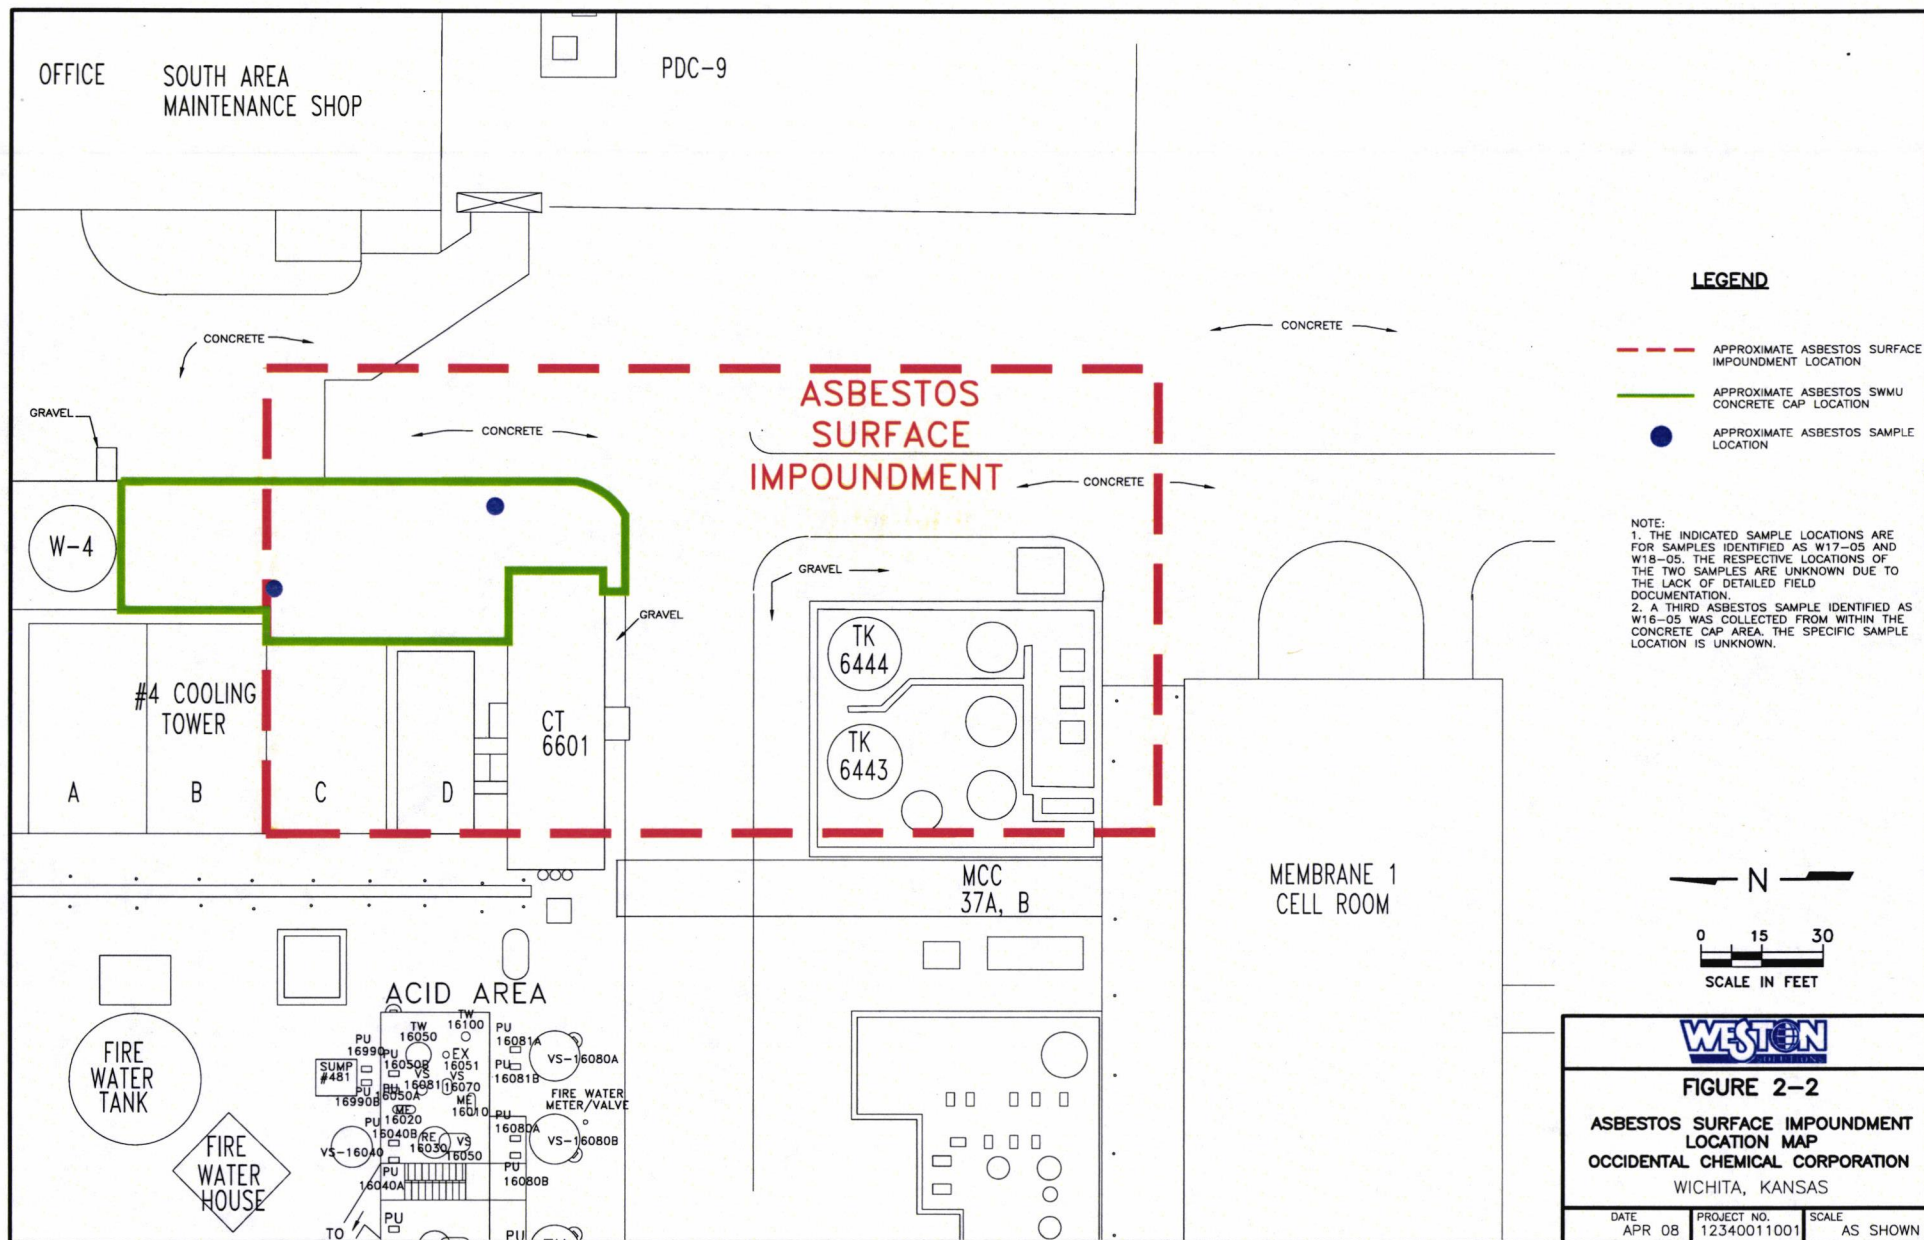
The full extent of the ASI SWMU is greater than the extent of the current cap. However, as shown on Figure 2-2, the approximate area of the ASI outside the cap is covered with concrete paving associated with plant operational areas.

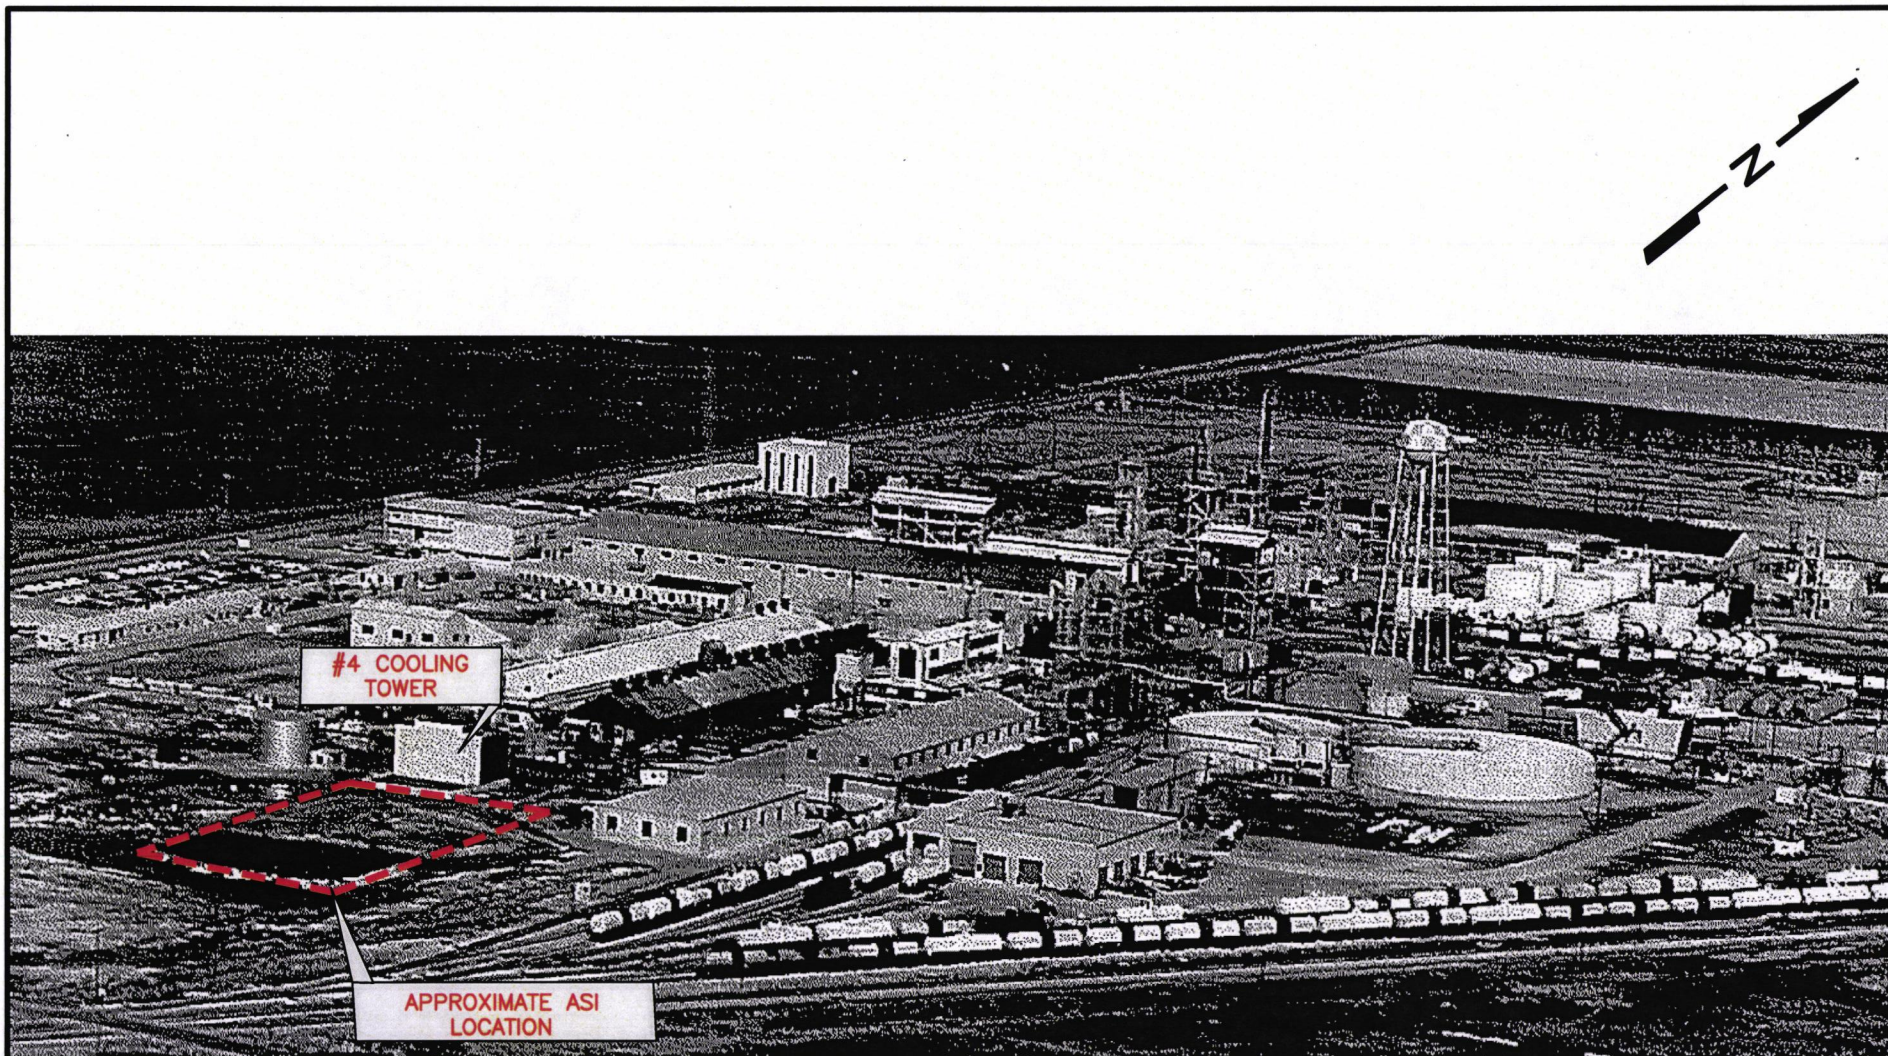
FIGURE 2-3
1961 AERIAL PHOTOGRAPH

Because of the potential for the presence of asbestos associated with historical operations, the area extending from the south side of the former pond to the area adjacent to Cooling Tower #4 was designated as the ASI area. The exact size of the ASI and the amount of asbestos in the area are currently unknown due to the absence of complete assessment data and the absence of historical production rates and tracking for on-site asbestos disposal. The size and approximate location of the ASI was determined primarily from the 1961 aerial photograph in Figure 2-3.

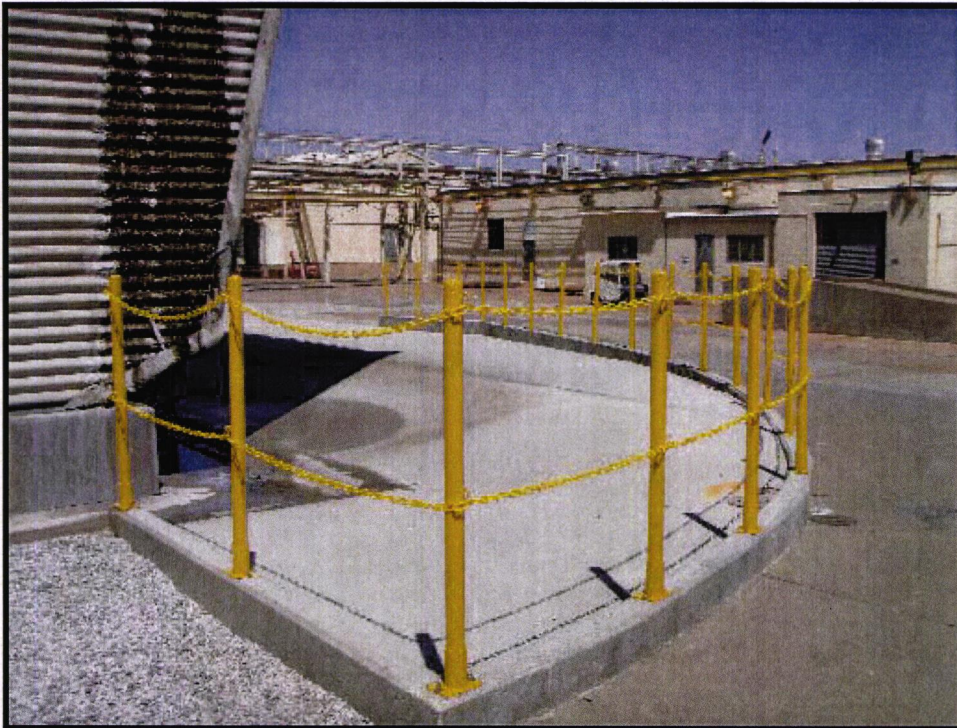
PHOTOGRAPH NO. 1

Concrete cap located adjacent to the east of cooling tower.

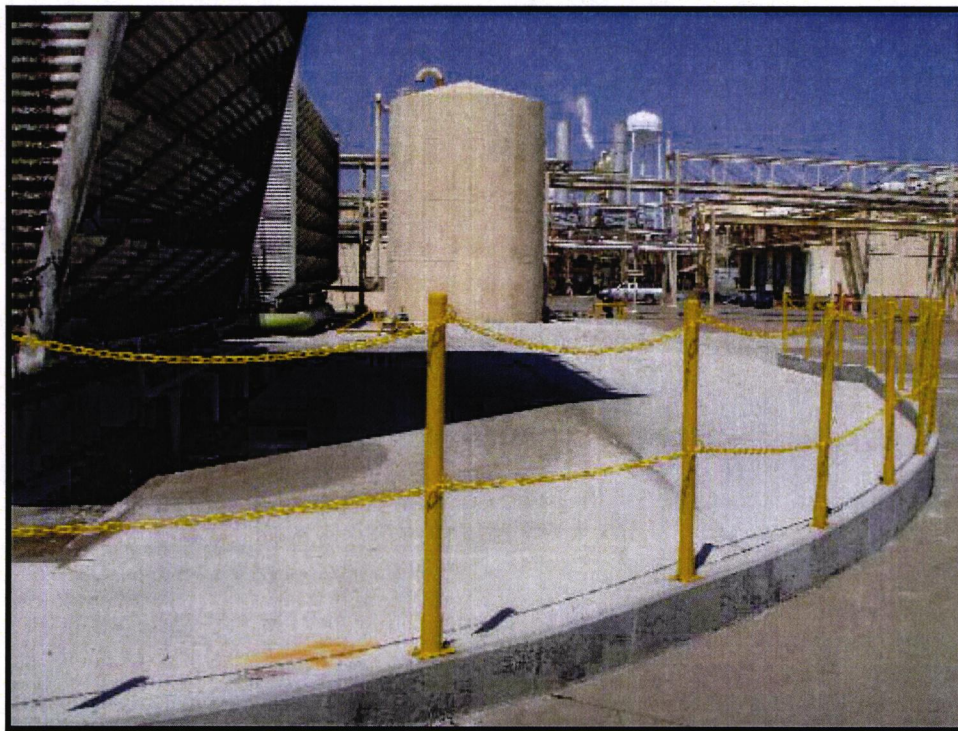
PHOTOGRAPH NO. 2

View of the concrete cap from the south.

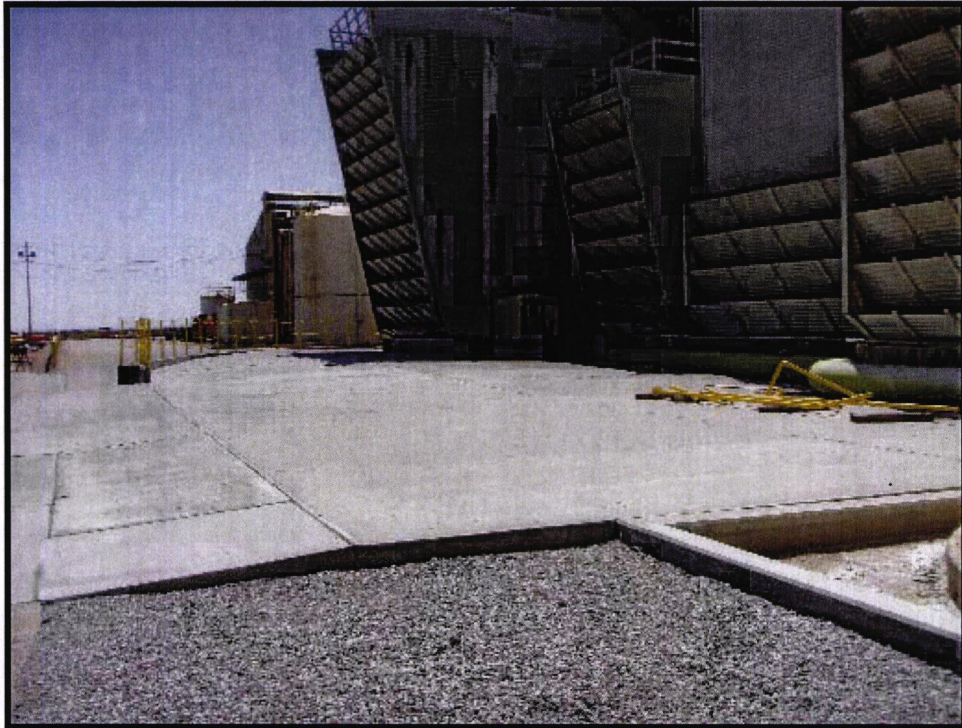
PHOTOGRAPH NO. 3

View of the concrete cap from the north.

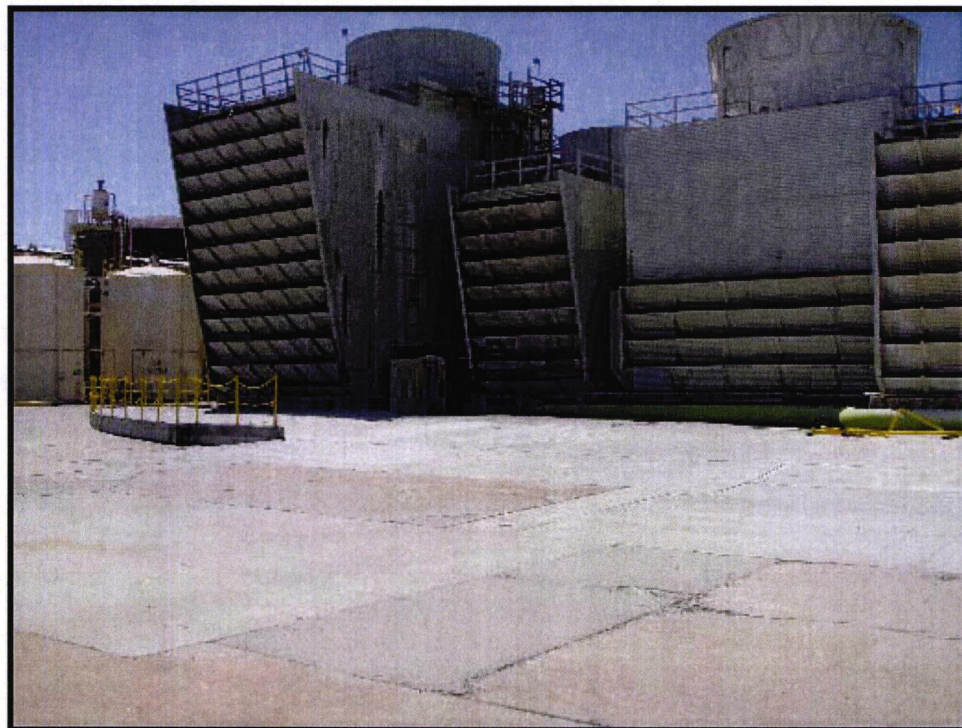
PHOTOGRAPH NO. 4

View of the concrete cap from the northeast.
